**Study Area Location Map**  
*Lower Passaic River Restoration Project*

*Lower Passaic River Restoration Project*

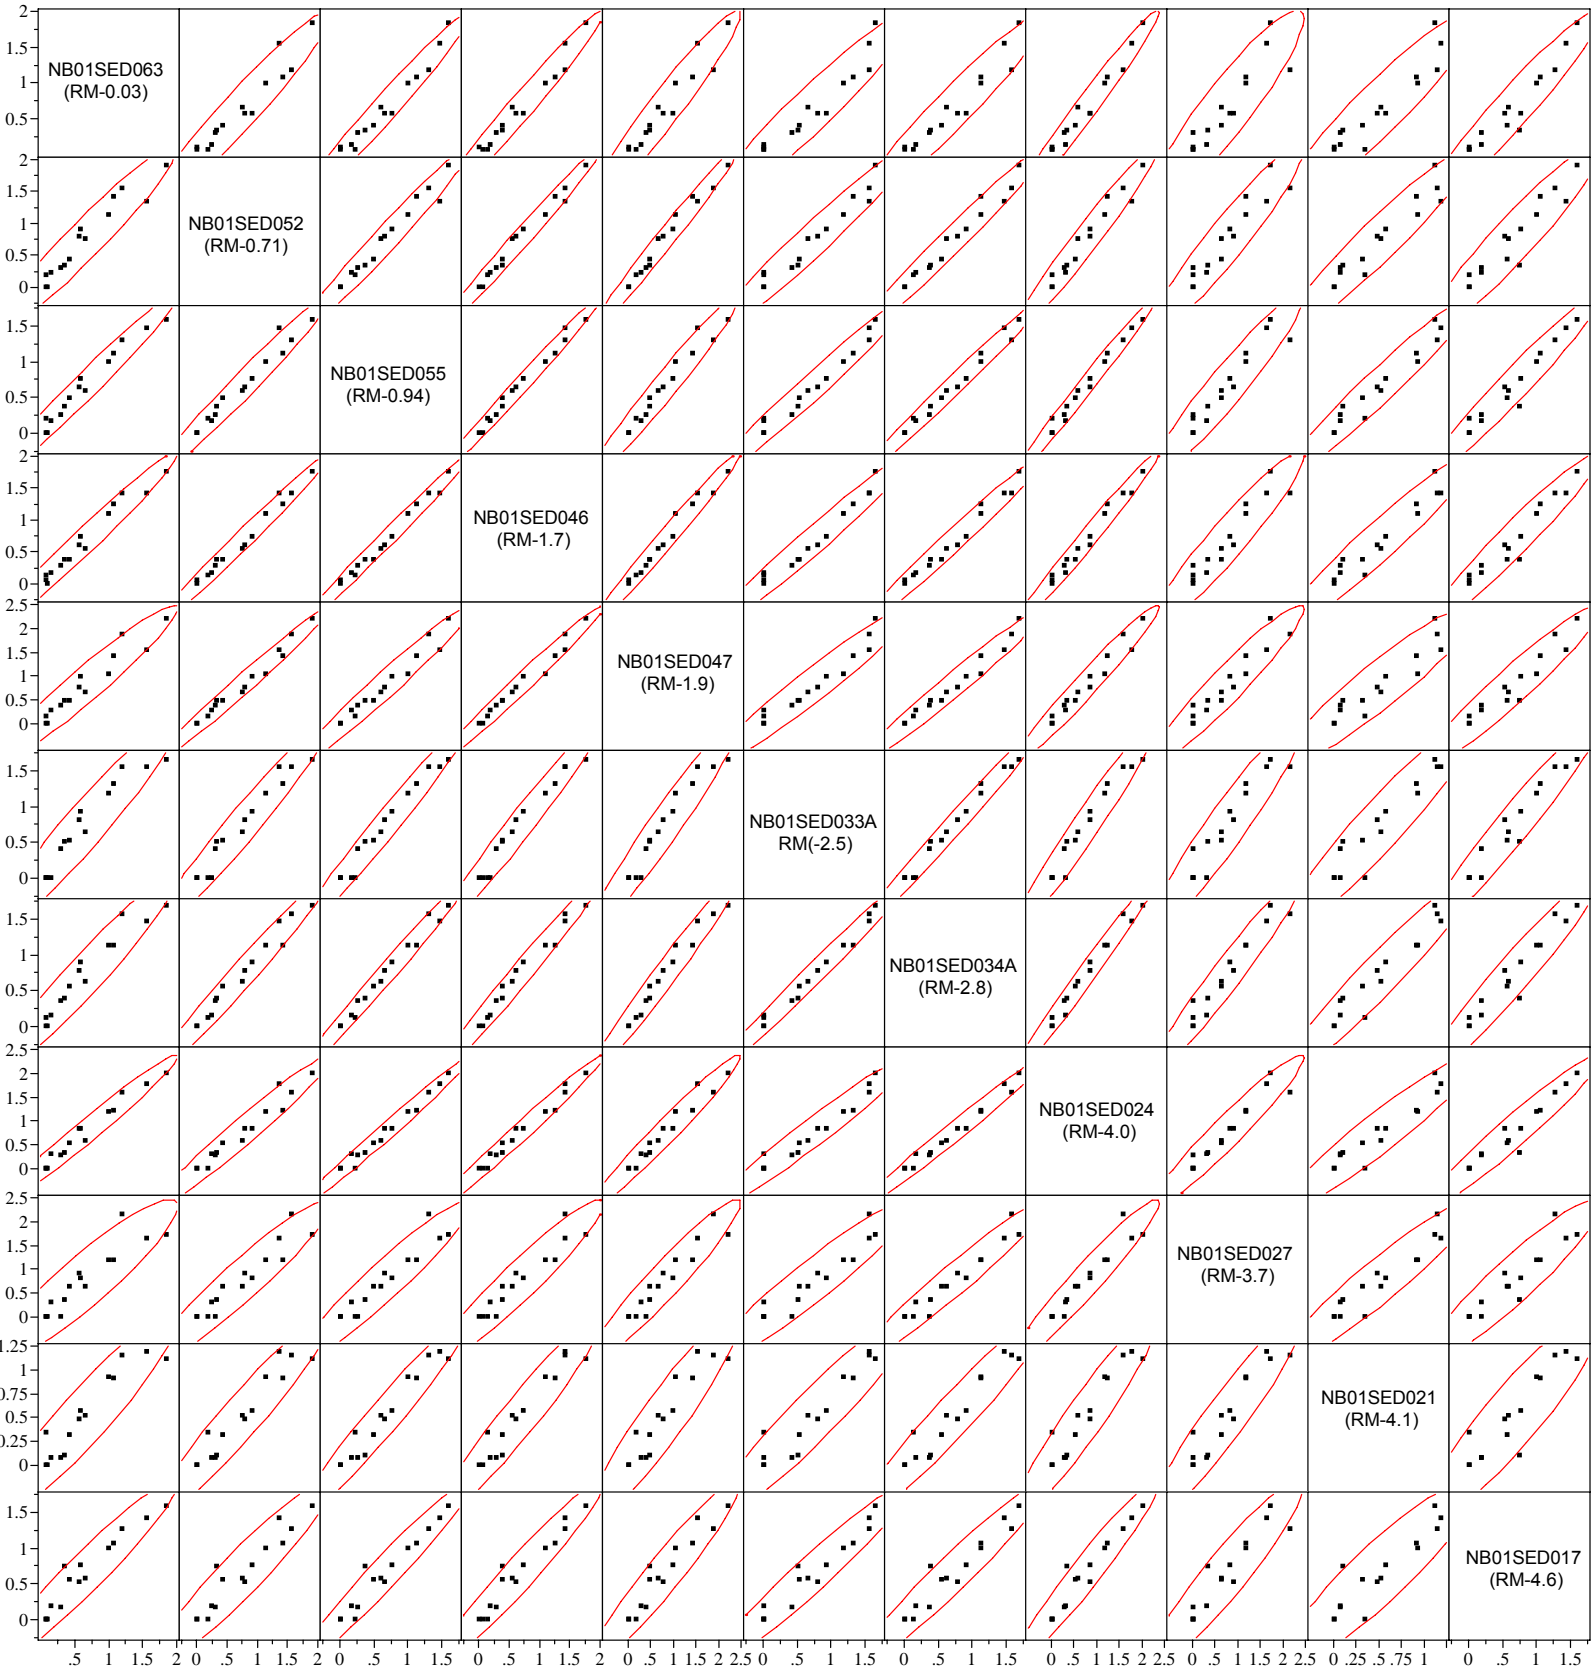
Figure 6-8

PAH Compounds  
normalized to dieldrin.

Correlation Among Sampling Locations of PAH  
Compounds in Newark Bay Samples

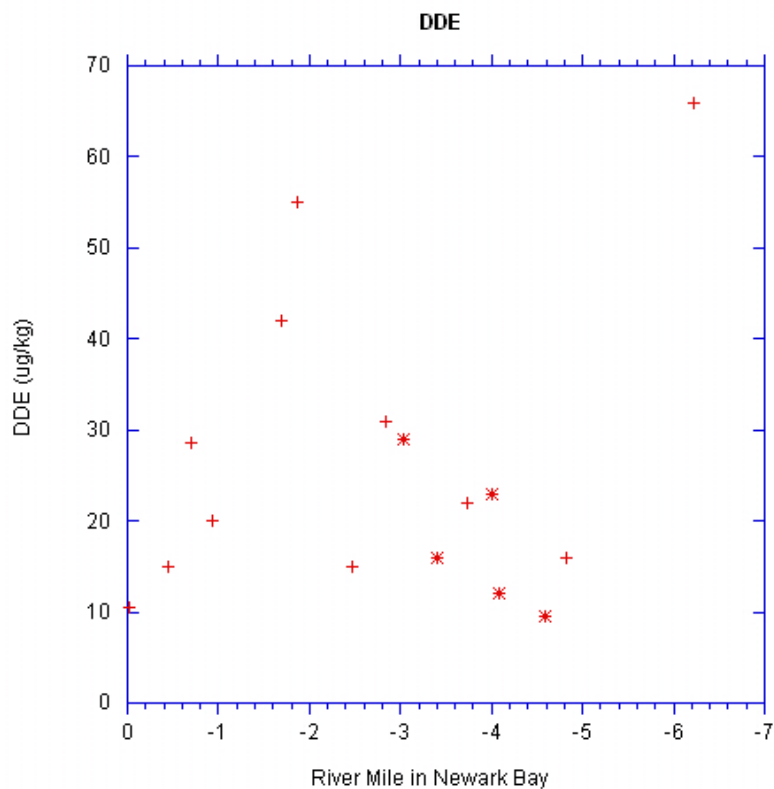
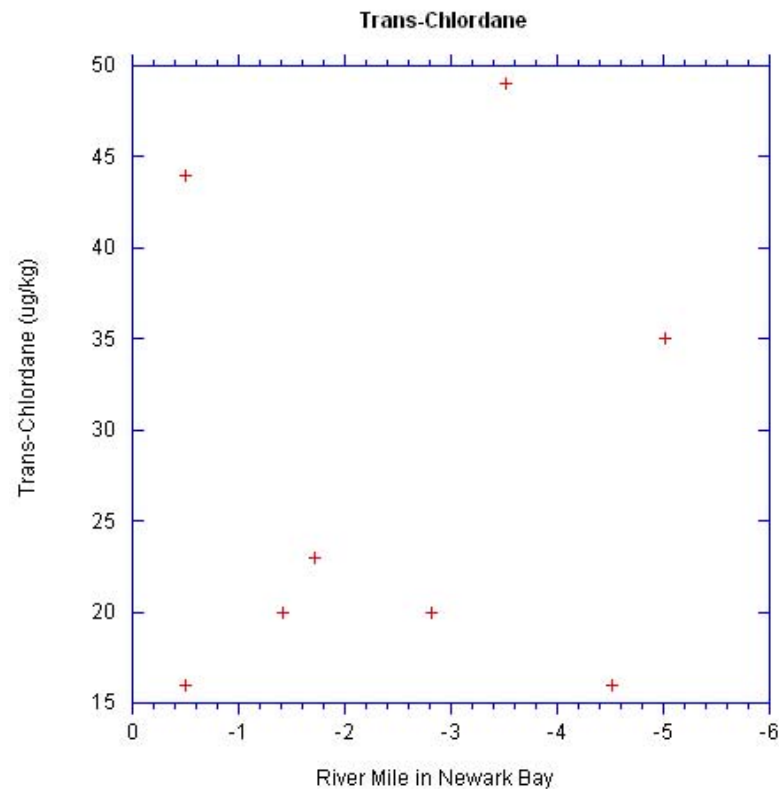
Figure 6-10

DDE represents only 4,4'-isomer.

Plot only shows the selected 16 depositional locations that are located in the federal navigation channel.

Pesticides Surface Sediment Concentrations in Newark Bay

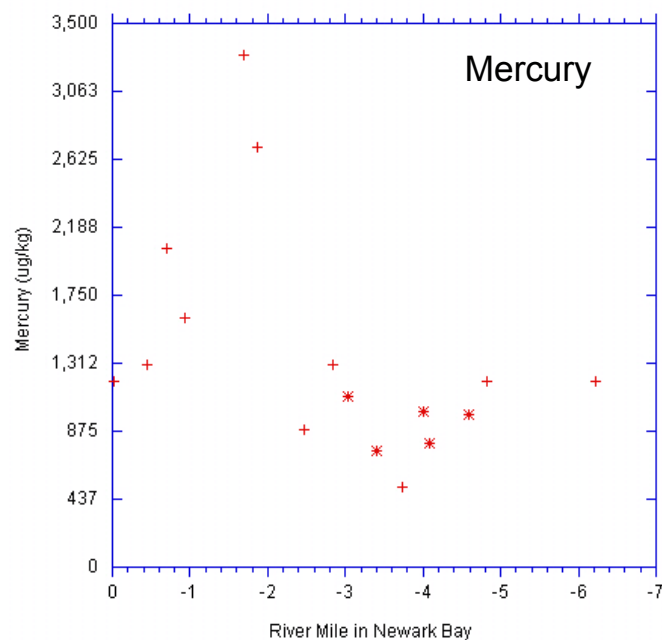
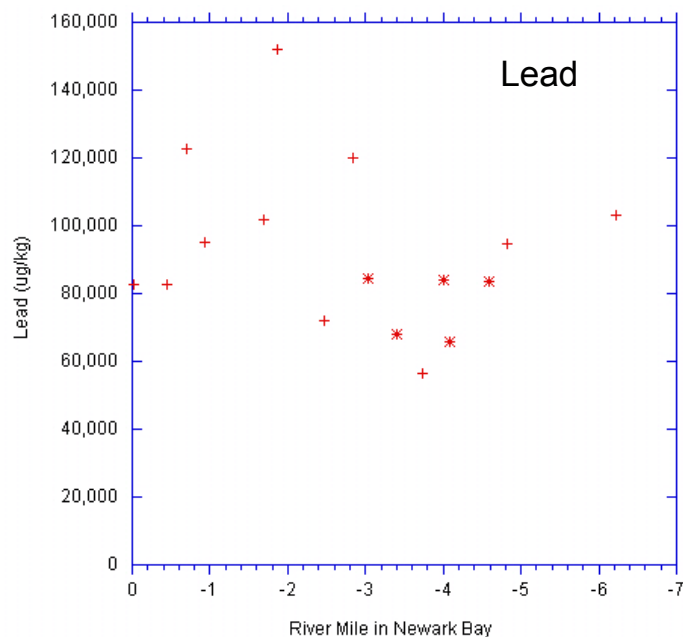
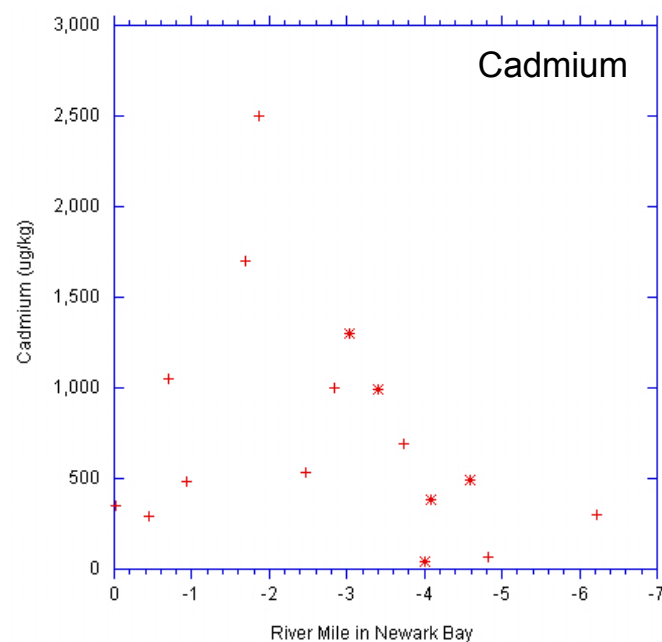
Figure 6-11

Plot only shows the selected 16 depositional locations that are located in the federal navigation channel.

## Metal Surface Sediment Concentrations in Newark Bay
